Corrosion during seabed storage - PPCoN Pipe Testing Programme

RF-1998/274

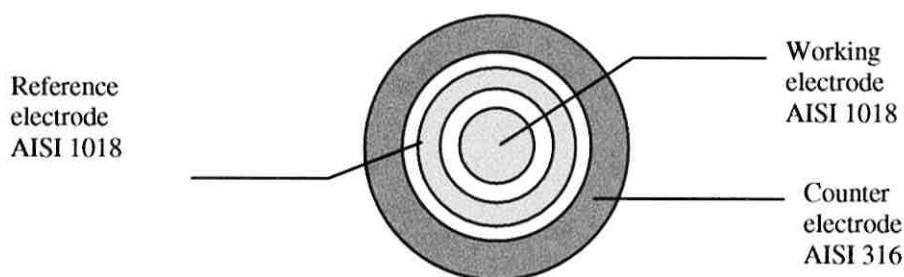
Corrosion probes were fitted into the test pipes before they were placed on the seabed. Figure 1a. shows the shape of the probe. The inner disc is the working electrode with the reference ring outside. The outer ring / body is the counter electrode. The material of working and reference electrode is UNS G10180 (AISI 1018) carbon steel while the body is made of UNS S31600 (AISI 316). The area of the working electrode was approximately 0,78 cm² for the 6 and 9 months exposure pipe and 0,07 cm² for the 3 months exposure pipe.

Figure 1a. Sketch of the corrosion probe.

Corrosion assessment: Corrosion measurements were performed on-site. Each pipe was fitted with a corrosion probe (LPR, see Fig 1a.) before placed on the seabed. The probes were fitted at 6 o'clock position (see Fig. 1b.). The cathodic polarisation measurements were performed with a portable computer, and from ambient corrosion potential to 300 mV below with a scan rate of 2.0 mV /sec. The electrochemical polarisation curves were obtained by Gamry CMS 100.

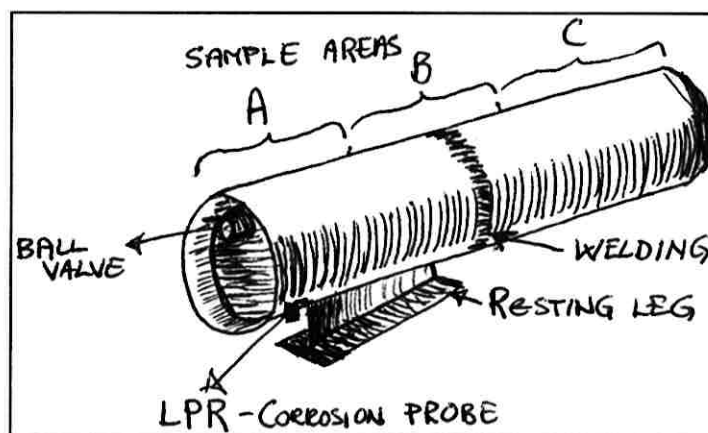
Figure 1b. Schematic drawing showing exterior attributes of test pipes.

Physical data pertinent to the pipes : 8 m total length/ 7.4 m length exposed to contained water, 3 cm wall thickness, inside diameter 34 cm, inside surface area 808.2 dm², bulk water volume 671.5 litres. The drawing (Fig.1) shows the positioning of the corrosion probe and the ball valve. The pipes were mounted on a resting leg for practical purposes. Samples recovered for surface analyses were labelled with reference to sample area A, B and C, and their clock position.

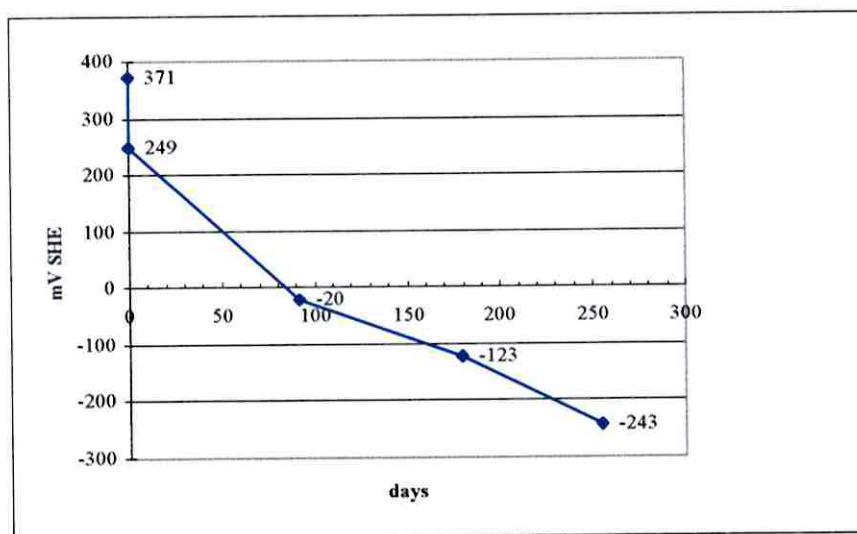
Figure 2. Redox potential (mV vs. SHE) as a function of time. 0-time shows redox potential of raw seawater (371 mV) and mean value (249 mV) of water collected from the pipes.

react with M^{2+} -ions and come out of solution as precipitate. The pH gradually increased, from typical seawater value 7.95 to 8.73 after 9 months. Apparently the pH stabilised in the period between 3 and 6 months. An increase in alkalinity was observed during the experimental period. This increase was expected as the pH had increased. However the alkalinity increase cannot have been the result of increase in total carbonate as there was no large available carbon source that could support this increase.

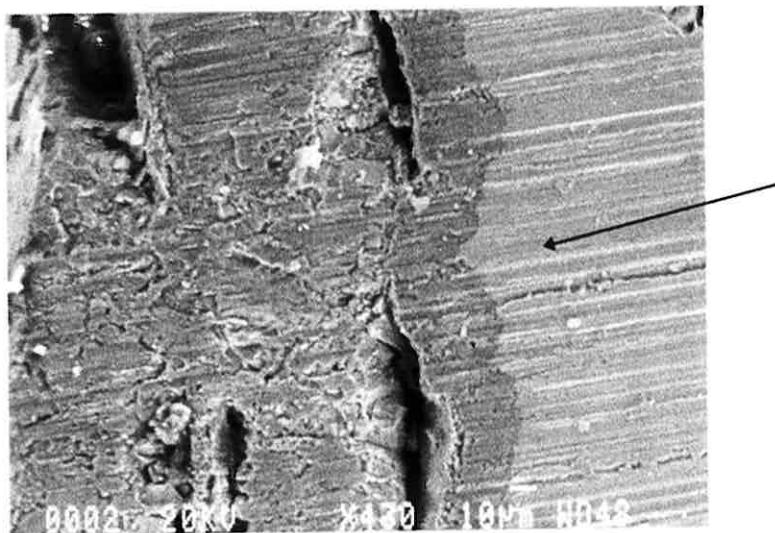
Figure 3. SEM micrograph of a cross section of corrosion product, 9 months exposure. The arrow indicates area of non-infested steel material.

A cross-section micrograph of the corrosion product is shown in Figure 3. The figure shows that the thickness of the corrosion layer was between 0.15 and 0.20 mm. There is also an indication that the surface is covered by two layers of different origin. It is believed that one is formed on the steel surface prior to exposure, while the other is formed during exposure. Some cracks in the products are shown as well. Other micrographs of the corrosion products are shown in appendix, Figures A.22.-26.

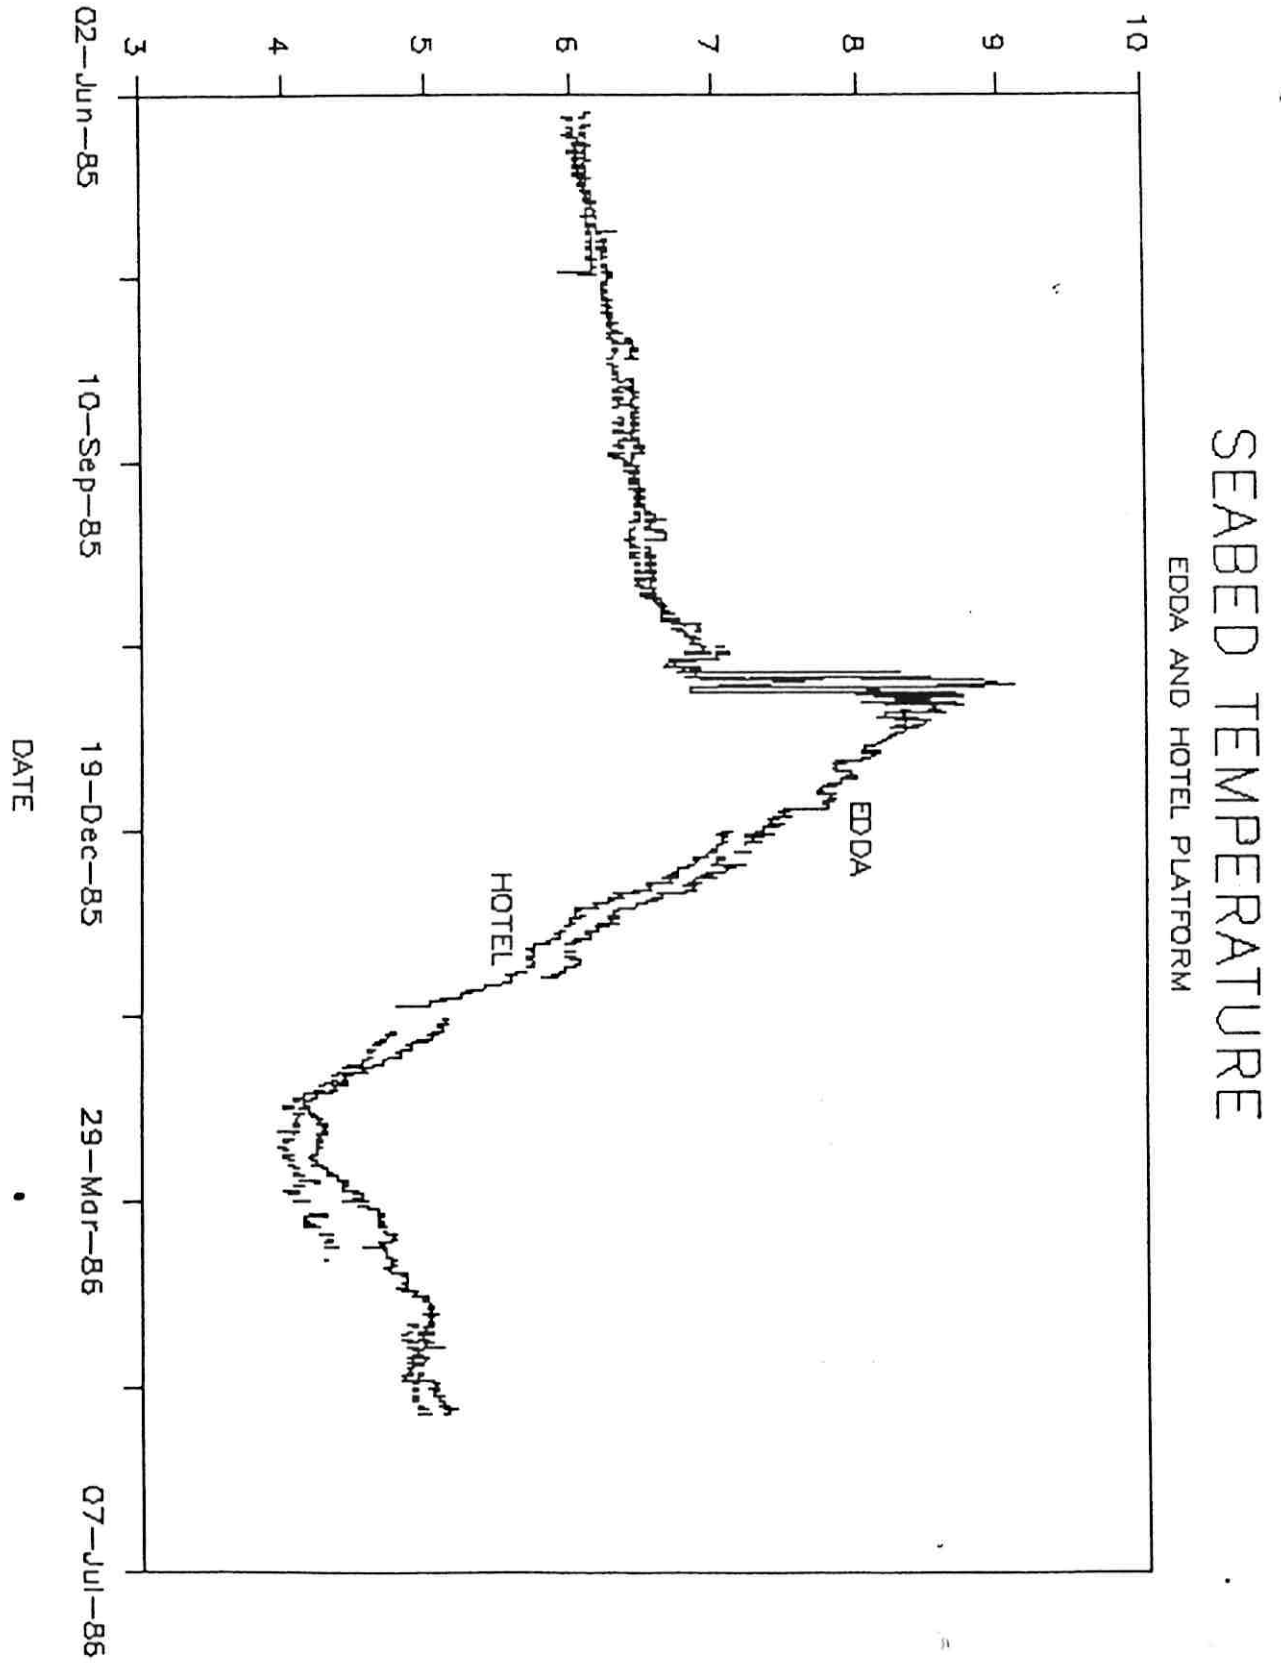
Figure A.5. Temperature cycle at the experimental area

is acknowledged as an important parameter as it also governs solubility of gases and ion equilibria. The relevance of the presented data is supported by the recorded data of temperatures at the seabed in the Ekofisk area, which can be read in Figure A.5., found in the appendix.

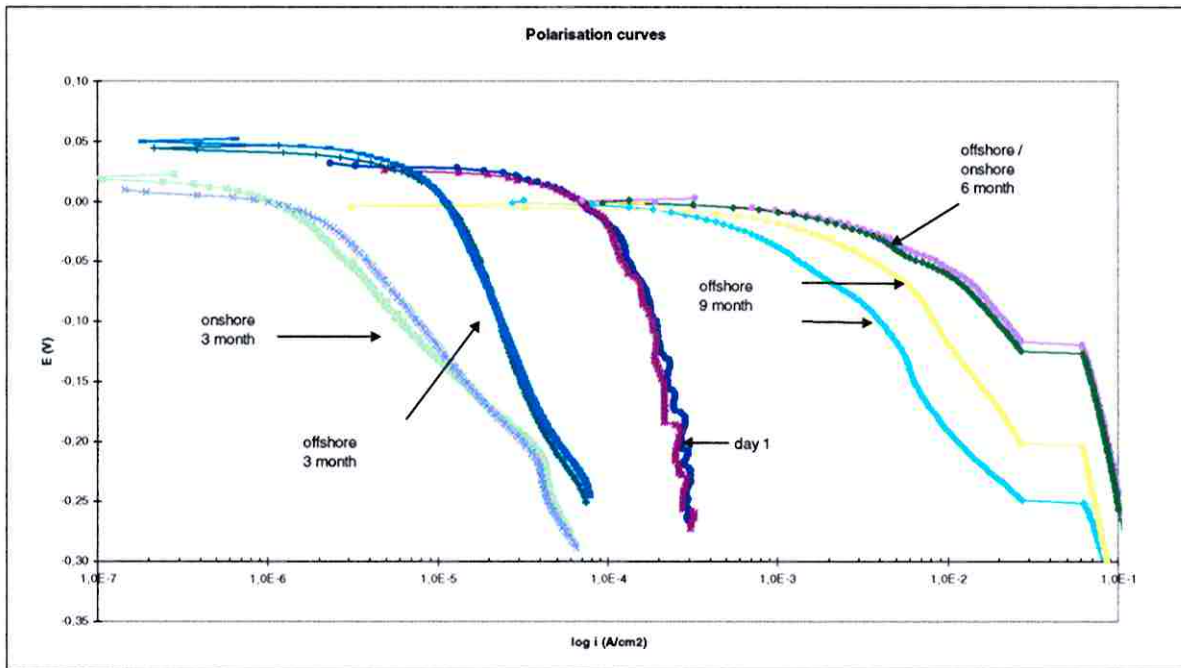
Figure A.6: Polarisation curves for day 1 (hours), 3 months, 6 months and 9 months exposure.

The shape of the curve after 6 months exposure indicated an ohmic resistance suggesting that the probe had been short circuited. Based on this observation the measurements were repeated onshore after the pipe had arrived at PPCoN Tananger. The results from the onshore measurements were exactly the same as found offshore (plotted in the same figure, Figure A.6.).

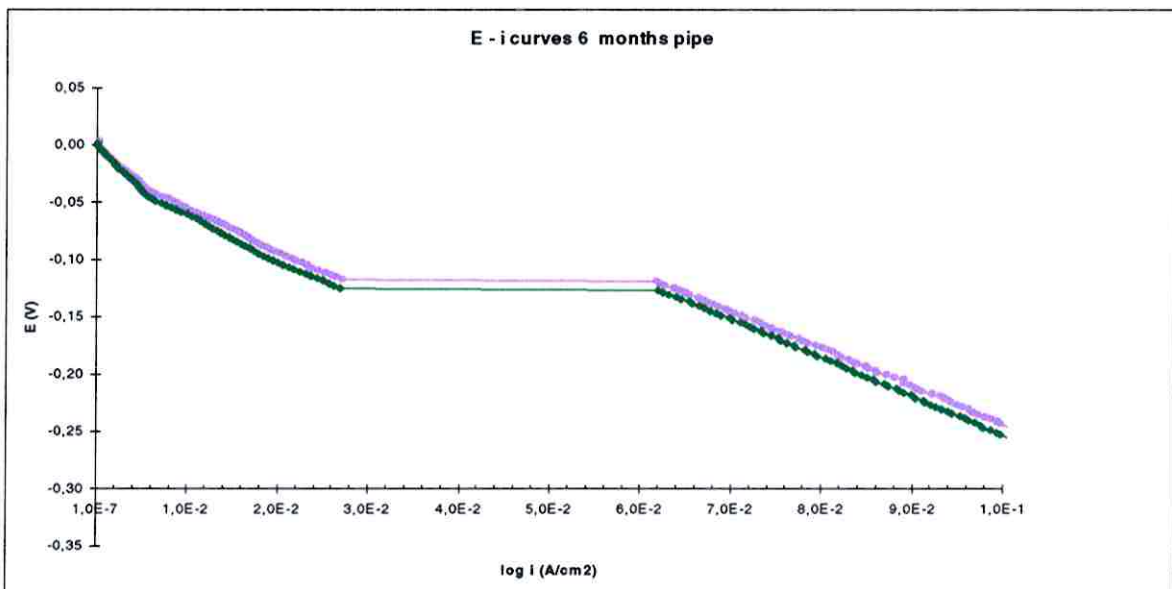
Figure A.7. Potential as a function of current for 6 months exposure.

Some solid material dropped off the corrosion probe when it was removed from the pipe. It was believed that this solid material had short-circuited the counter and reference electrodes on the probe, and the product was taken to the laboratory for analysis to determine whether or not the material was electrically conductive (see Fig. A.10 in appendix to see how the probe was fitted to the inside surface). It was verified that the composition of the surface of this material was similar to that of the other corrosion products sampled (see Appendix) and it was concluded that the material was electrically conductive and this could explain the non-exponential profile of the polarisation curve. Plotting the potential as a function of current gave a linear curve, see Figure A.7. This can only be explained as an artefact of an Ohmic short circuit on the probe. The resistance of the short circuit can be determined from the slope of the curve and is found to be approximately 4 ohms.

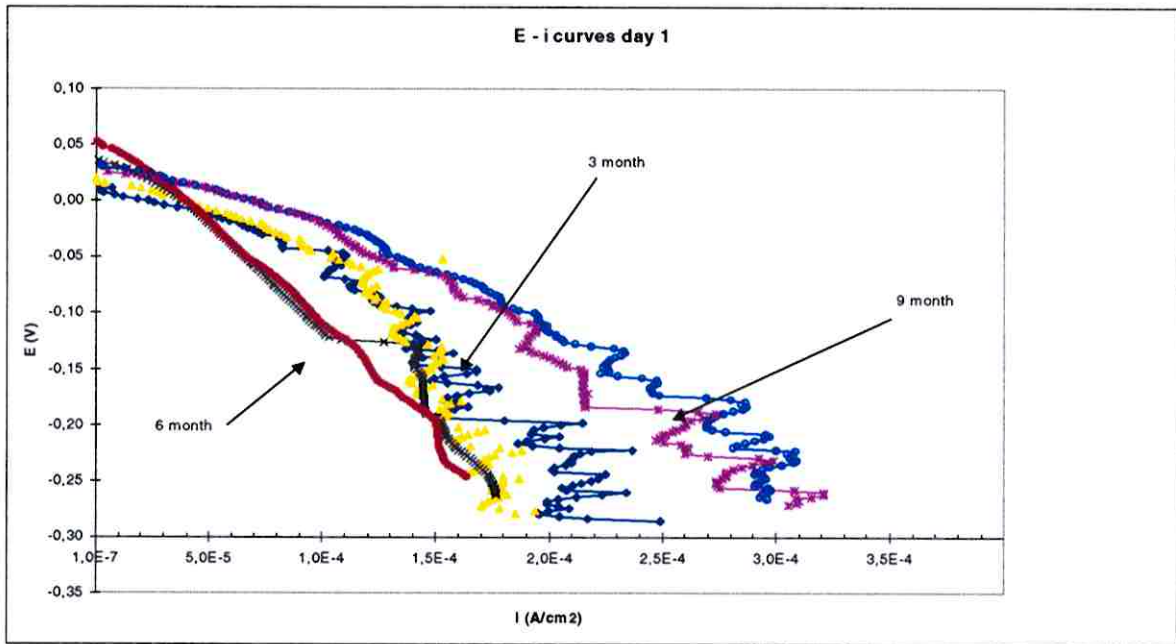
Figure A.8. Potential as a function of current for the different probes for day 1 (hour exposure).

Some linearity is also observed for the same probe at day 1 (see Figure A.8.). The slope of this curve represented approximately 1580 ohms.

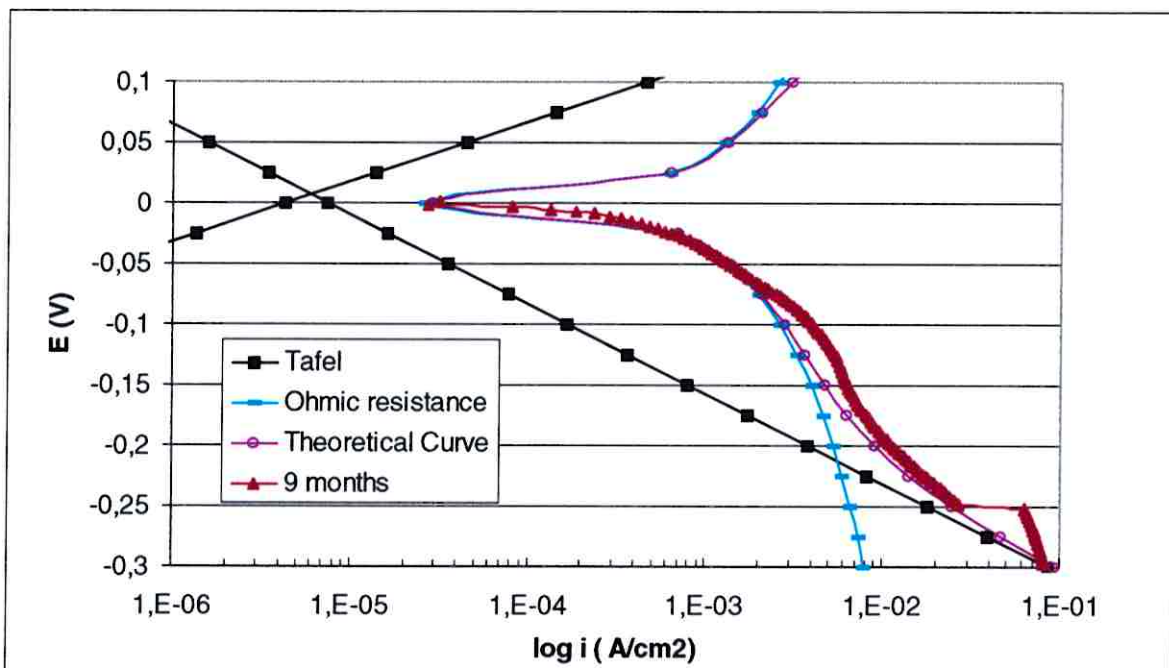
Figure A.9. Polarisation curve for 9 months compared with the theoretical reduction reaction based on activation controlled reaction (Tafel) and short circuit reaction.

The current densities after 9 months exposure are relatively high compared to the other valid measurements. As far as we can tell, there are no new reduction reactions that can account for this increase in current density. Therefore we cannot find any other explanation than a significant increase in the surface area where the cathodic reduction takes place. This could be caused by an electrically conducting corrosion product, such as iron sulphide or Fe_3O_4 , settling on the corrosion probe.

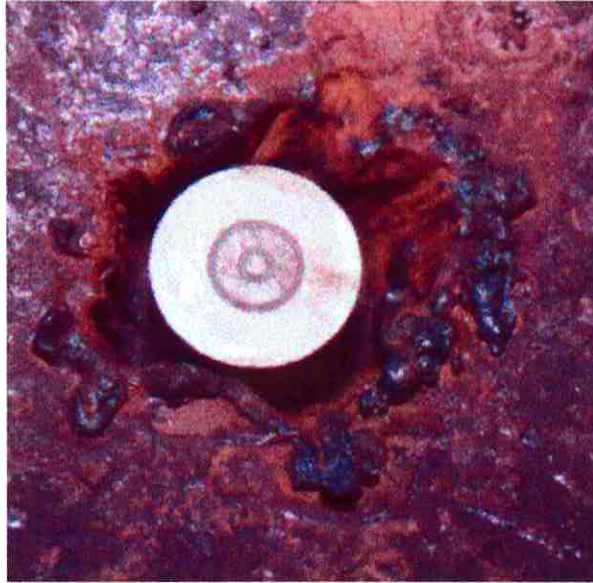
Figure A.10. The corrosion probe; close up as viewed from the inside of the pipes.

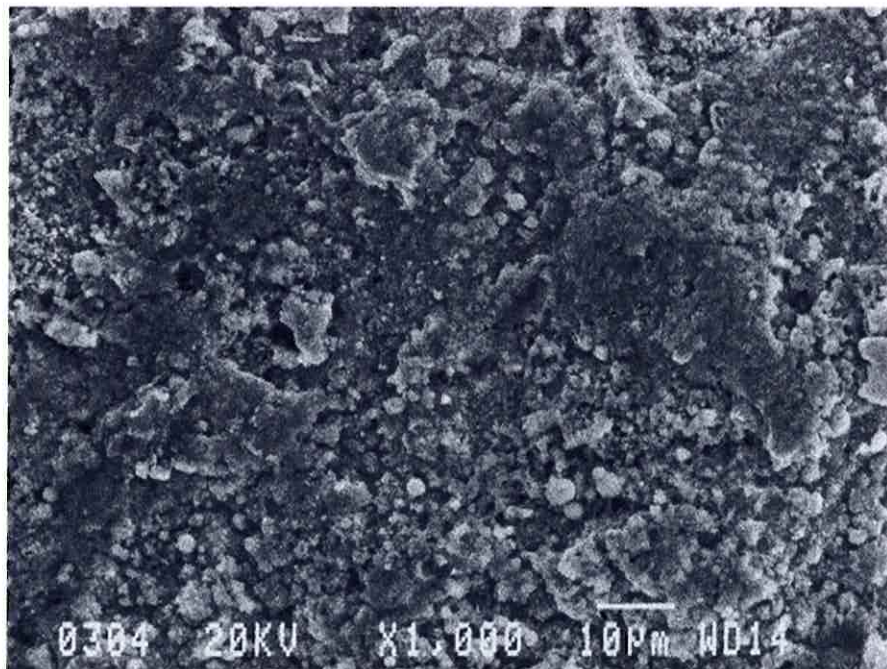
Figure A.11. SEM micrograph of the surface/corrosion product of unexposed pipe (magnification 1000X).

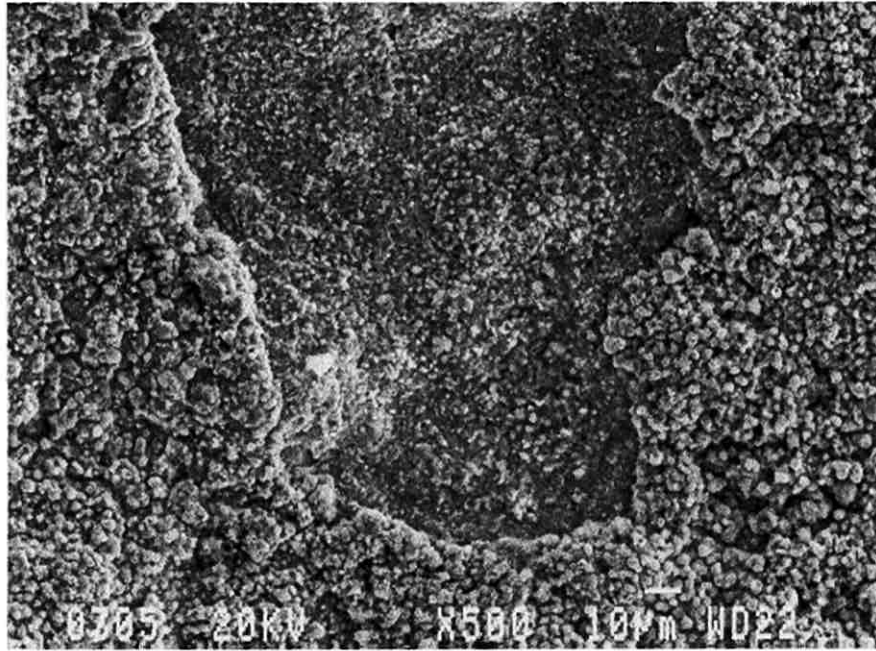
Figure A.12. SEM micrograph of the surface/corrosion product (magn. 500X), bottom of pipe, 3 months exposure).

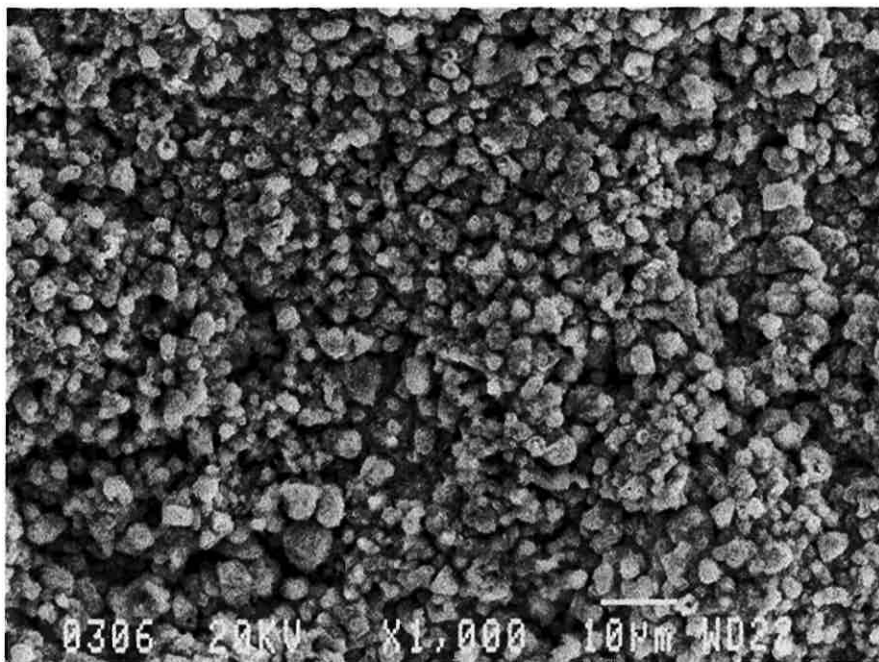
Figure A.13. SEM micrograph of the surface/ corrosion product (magn. 1000X), bottom of pipe, 3 months exposure

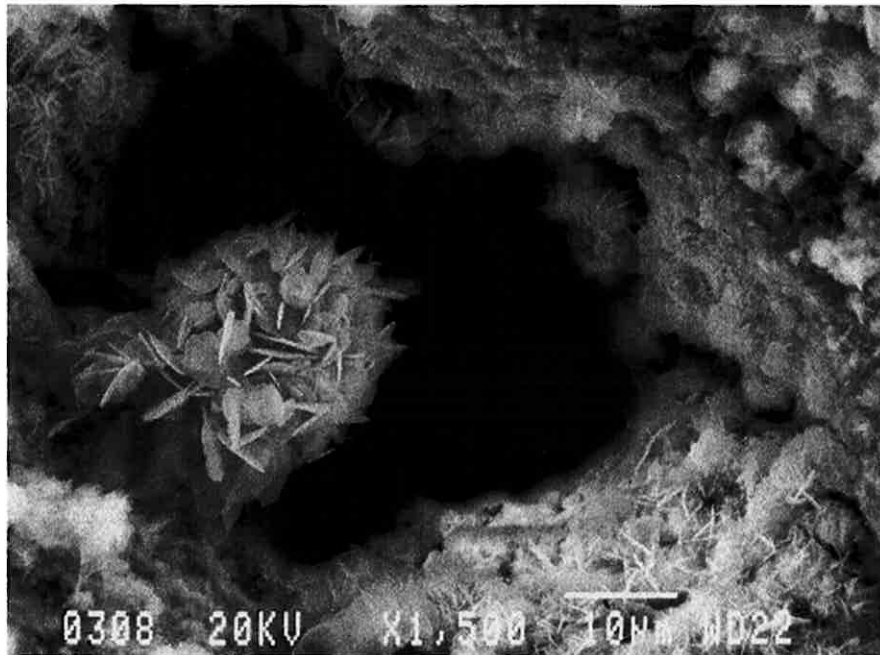
Figure A.14. SEM micrograph of surface deposits ("cactus"), bottom of pipe, 3 months exposure (magn. 1500X).

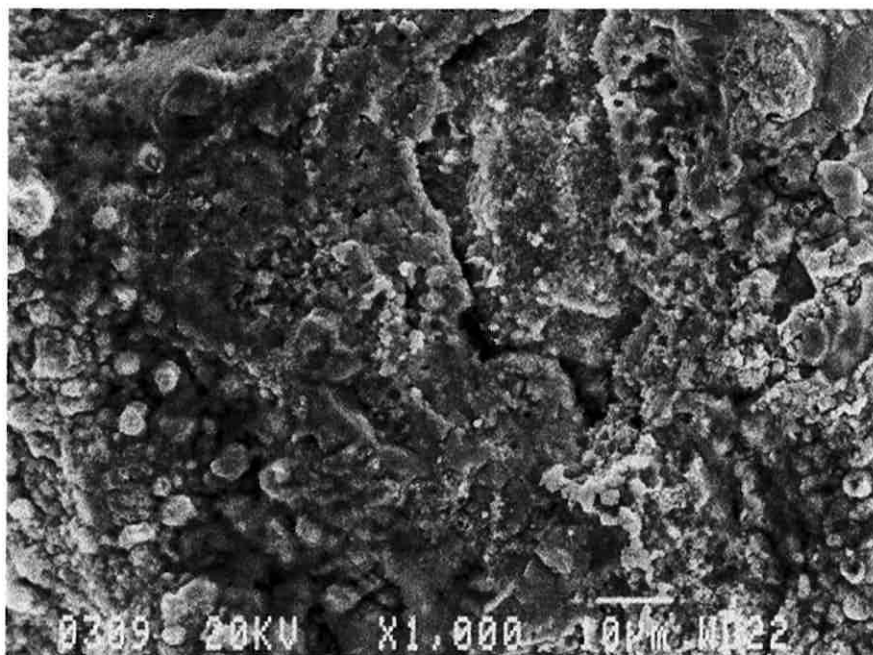
Figure A.15. SEM micrograph of the surface/corrosion product adjacent to the weld (2 halves were welded to one pipe length), 3 months exposure (magn. 1000X).

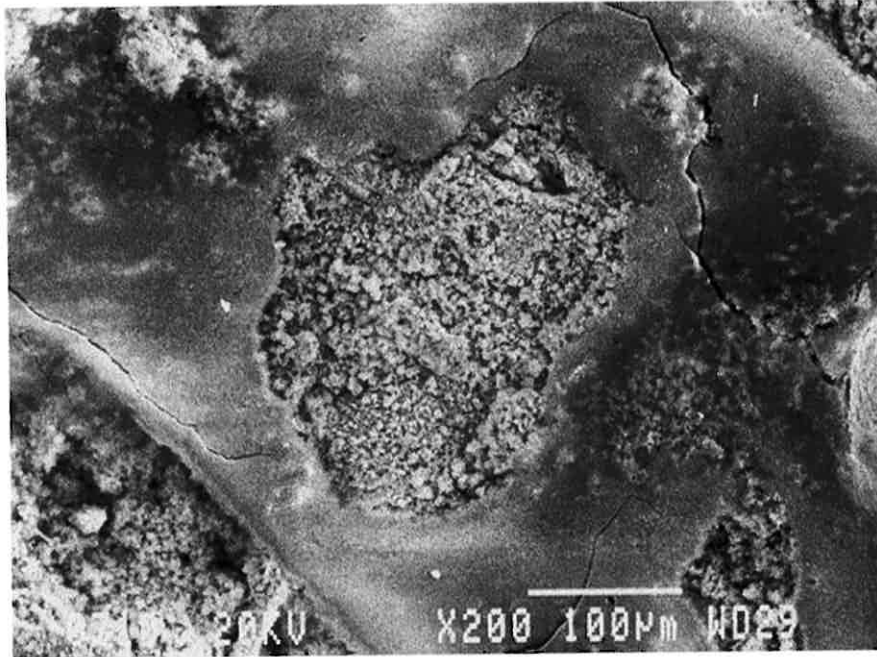
Figure A.16. SEM micrograph of corrosion products/deposits removed from the pipe; 3 months exposure (magn. 200X).

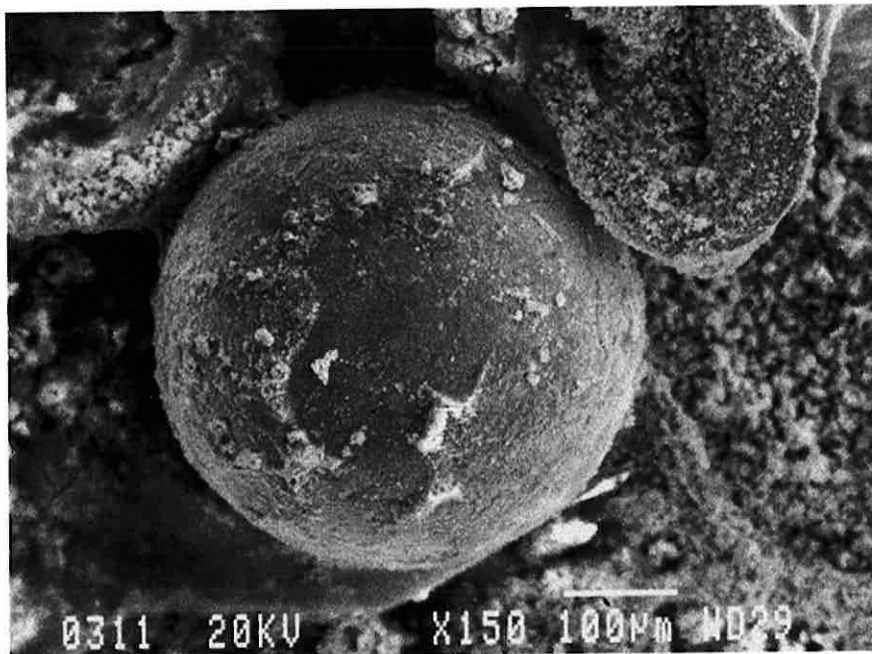
Figure A.17. SEM micrograph of a generic corrosion product; sampled from the pipe 3 months exposure (magn. 150X).

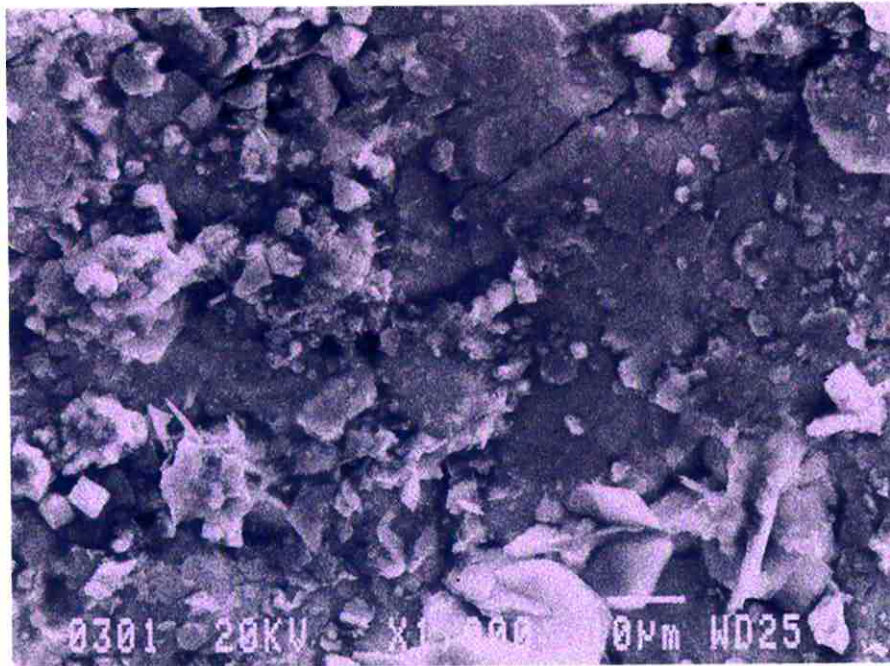
Figure A.18. SEM micrograph of the surface/corrosion product, 12 o'clock, 6 months exposure.

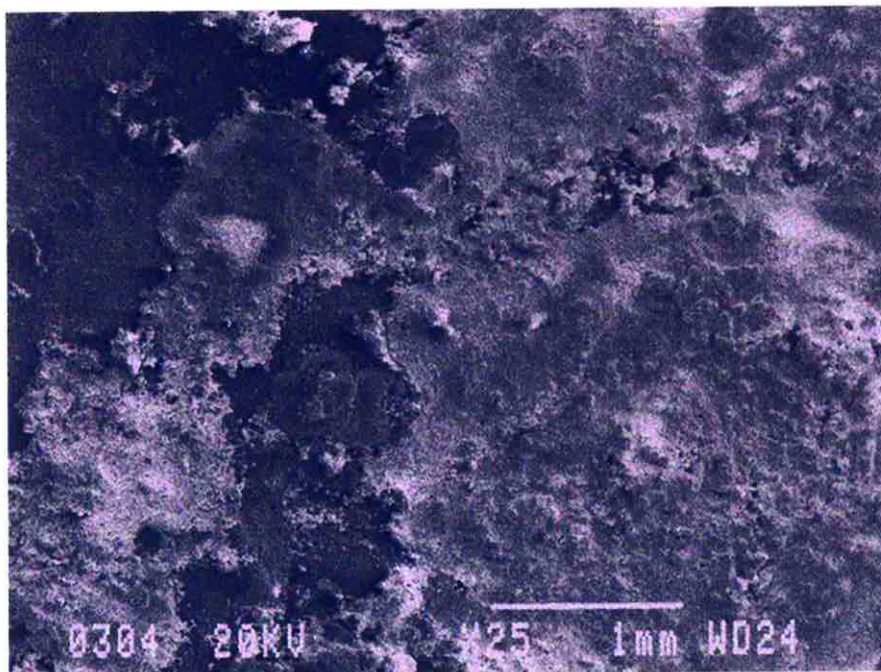
Figure A.19. SEM micrograph of the surface/corrosion product, 12 o'clock, 6 months exposure.

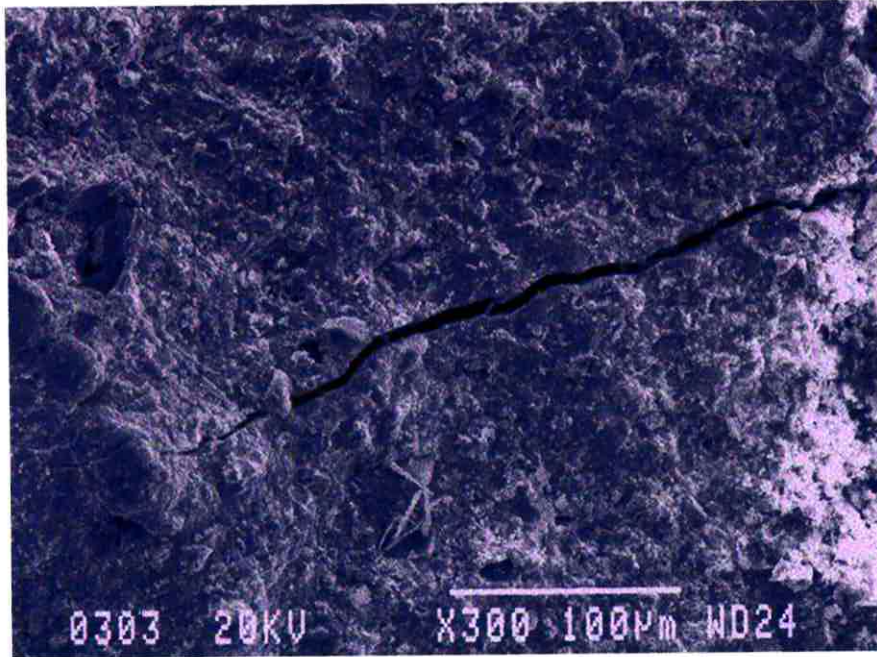
Figure A.20. SEM micrograph of the surface/corrosion product, 12 o'clock, 6 months exposure.

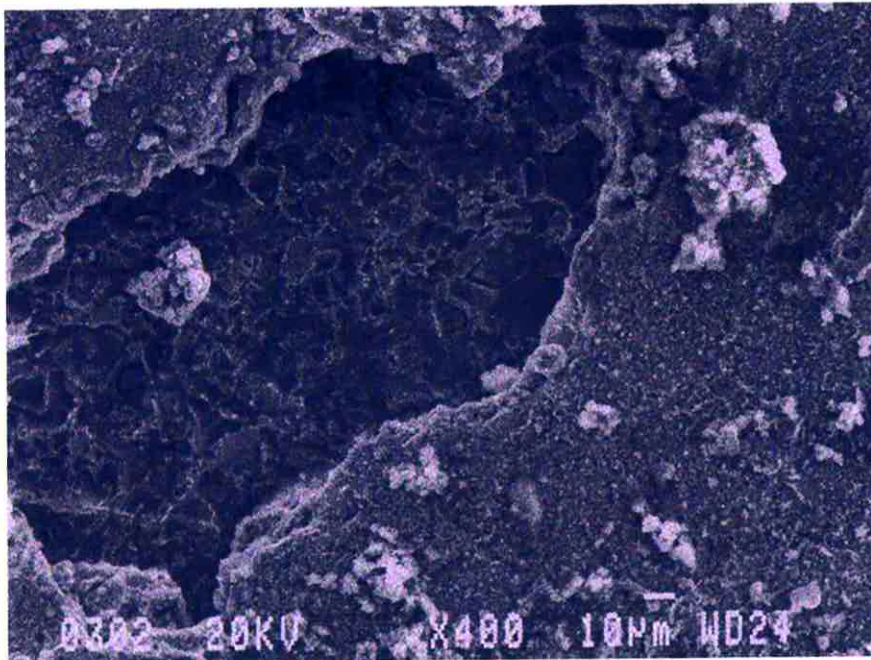
Figure A.21. SEM micrograph of the surface/corrosion product, 3 o'clock, 6 months exposure.

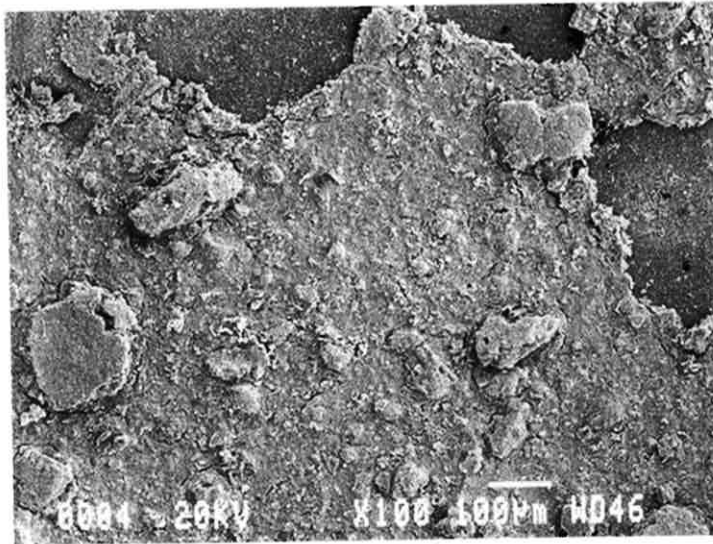
Figure A.22. SEM micrograph of the filter covered with Au, magnification X100 (9 months)

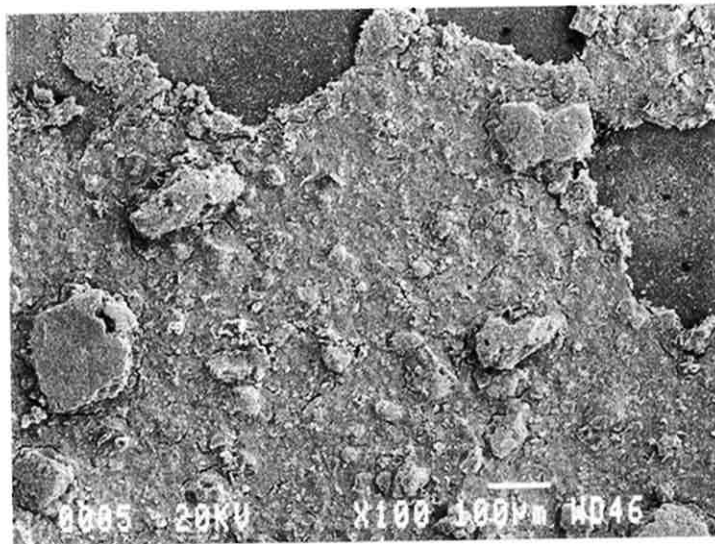
Figure A.23. Same image as in figure A.22, only this time without Au cover.

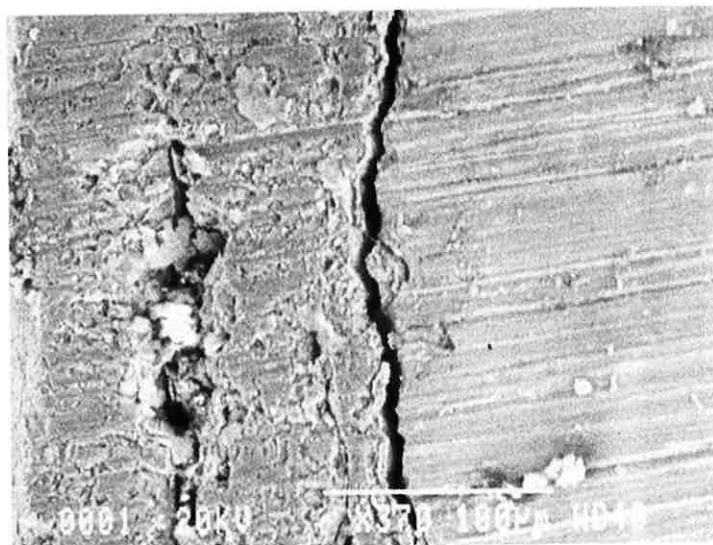
Figure A.24. 9 month / sample C3, cast-in copper (Cu); cross-sectional view 1.

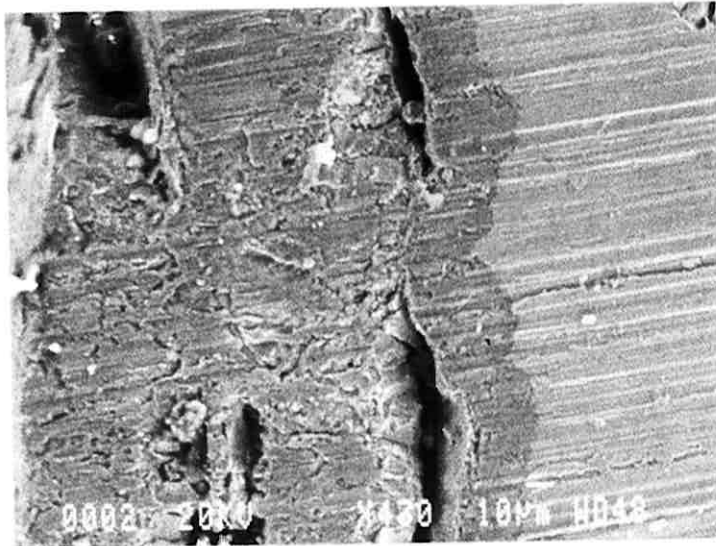
Figure A.25. 9 month / sample C3, cast-in copper (Cu); cross-sectional view 2.

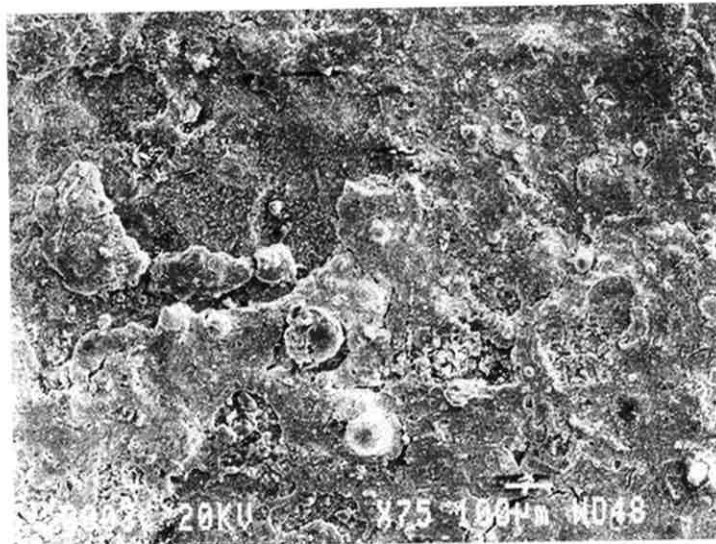
Figure A.26. 9 month / sample A3; corrosion product, some cracks in the layer.

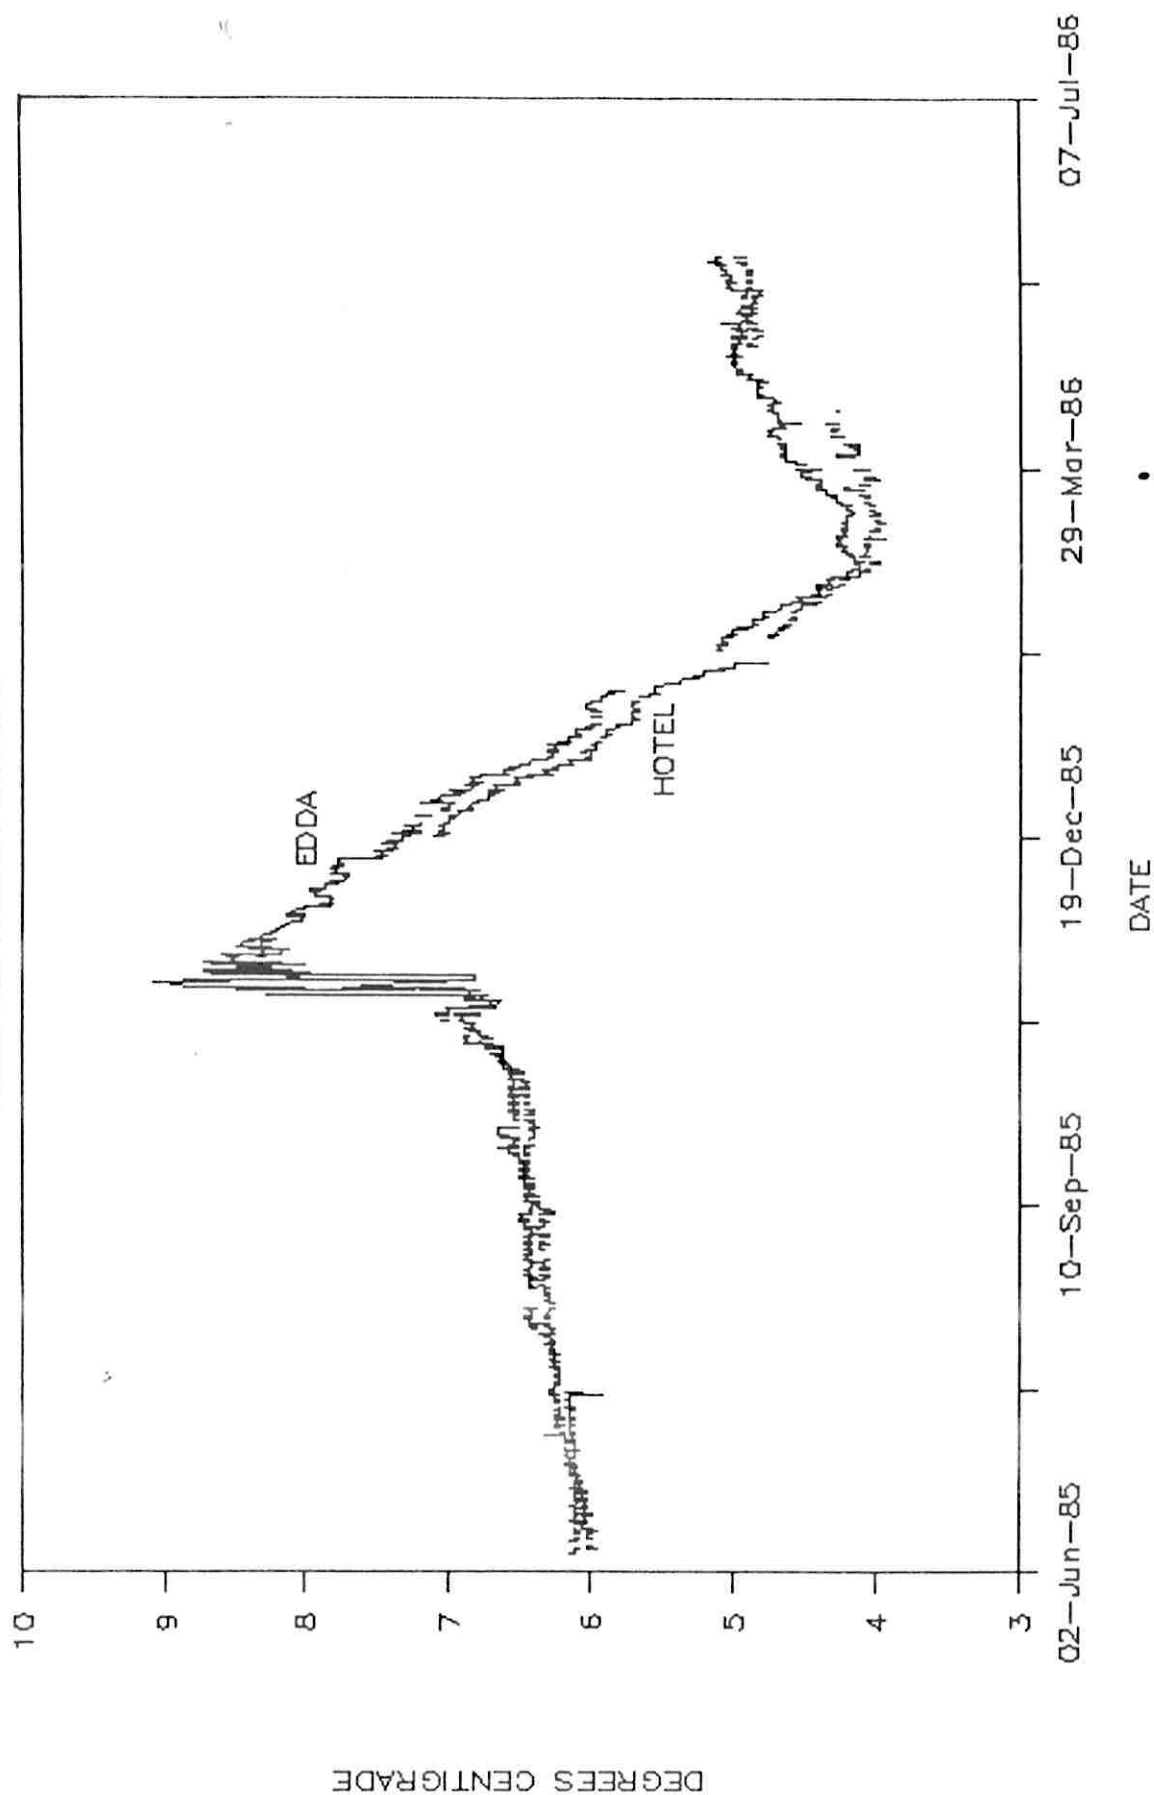
SEABED TEMPERATURE

EDDA AND HOTEL PLATFORM
