Restoration of annular zonal isolation using localized casing expansion (LCE) technology: Treatment of near-horizontal test sections containing a free-water channel

K. Beltrán-Jiménez^a, H.J. Skadsem^{b,a,*}, J.K. Sunde^a, D. Gardner^a, T.K.T. Wolterbeek^c, E.K. Cornelissen^d, W.J.G. Keultjes^d

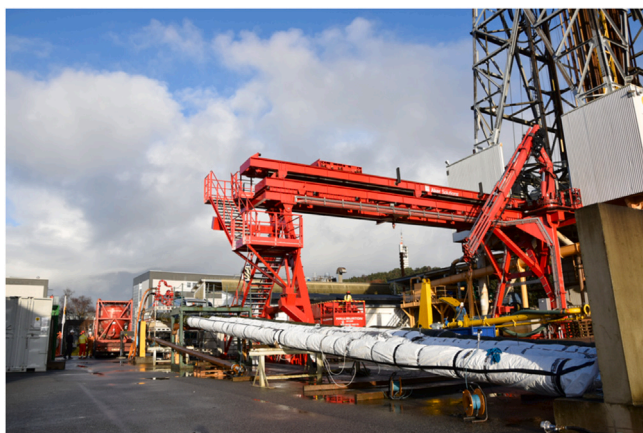
Fig. 1. View of the four test assemblies draped in insulation and plastic covers.

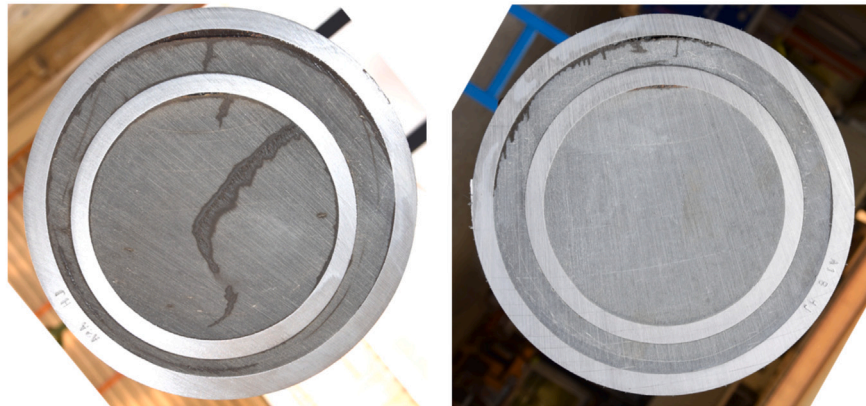
(a) In assembly A2, the eccentricity of the inner 7-in. tubing is approximately 0.45 at the left end (0.0 m) and close to centralized at the right end (8.8 m). Continuous millimeter-sized channels were present on the top side of the cement in the annulus and in the tubing.

(b) In assembly C6, the eccentricity of the inner 7-in. tubing is approximately 0.75 at the left end (0.0 m) and approximately 0.6 at the right end (8.3 m). Debris, voids and severely fractured cement occupied the annular space at the left end of the test assembly. The condition of the annulus cement improved toward the right end where a millimeter-sized channel remained.

Fig. 2. Ends cross sections of test assemblies A2 and C6 selected for the remediation experiment.

The annular migration paths were characterized by (1) flow testing and (2) physical point measurements using a measurement stick inserted through test ports drilled in the outer casing. Based on the physical point measurements, the maximum gap width was estimated to be between 1 and 1.5 mm in assembly A2 and between 1 and 15 mm in assembly C6. These measurements agreed with visual inspection of the exposed end cross sections (Fig. 2). The largest gap width in assembly C6 was measured through a test port close to the near end at 0.3 m.

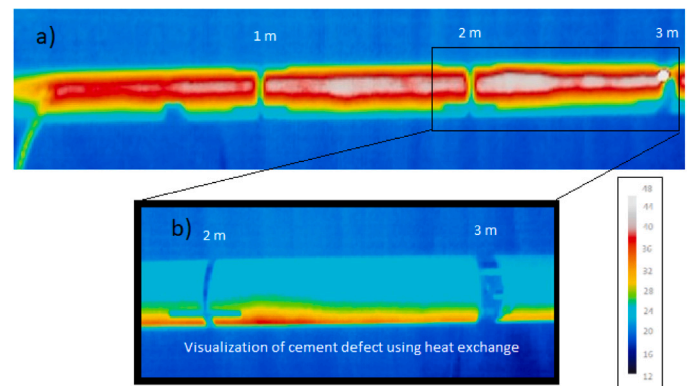
Fig. 6. Warm water (40 °C) injection in assembly C6. Water is injected from right to left. (a) Picture of the interval between 0.0 m and 3 m after 30 min since start of injection. (b) Detail of a part of the assembly rotated by 90° showing that surface heating was limited to the region of the migration channel.

For assembly C6, some uneven heating spots in the interval from 0.0 to 3 m were observed. These are indicated in Fig. 6 and are likely connected to the poor initial cement quality in this end of assembly C6. Fig. 6(b) shows a side view of part of the assembly, showing that the surface heating of the outer casing occurred at the orientation of the top annular channel.

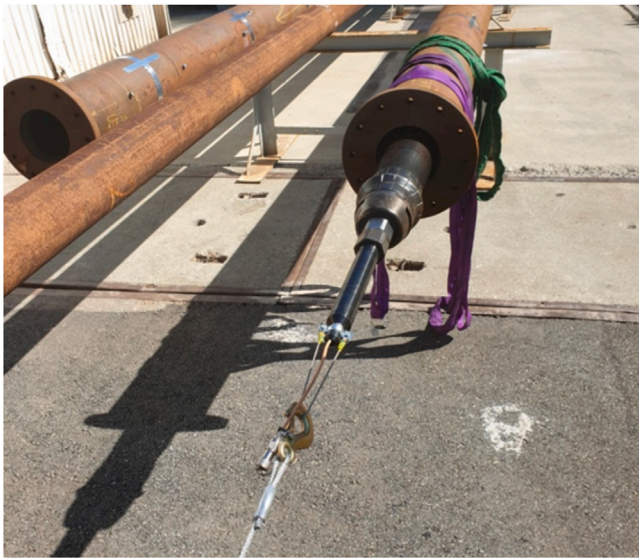
Fig. 7. The casing expansion tool partly inside one of the test assemblies. A dual winch system was used to position the tool inside the assemblies prior to each dent.

The remediation experiment was performed in an indoor test hall and using a dual winch system to correctly position the tool inside the test assemblies. Several sets of dents were planned at different positions in the two assemblies and additional pressure ports were mounted to allow flow testing of individual sets of dents. The test ports were installed at the top of the annulus, ensuring direct communication with the migration channel at the top of the annular cement. The axial positions of the planned dents are shown in Table 4 where the lengths are measured in accordance with the cross-sectional orientations in Fig. 2 and the schematic provided in Fig. 8. As indicated, combinations of single and multiple dents were planned in order to gauge possible further reductions in annulus permeability with subsequent dents placed adjacent to each other. The order of dents is also indicated in Table 4. At locations where multiple dents were planned, the order of the dents was generally such that the left-most and right-most dents were placed first followed by the central dents. Also listed in Table 4 is the maximum tool current configuration in each of the sets of dents. The maximum current is indicative of the degree of pressure exerted on the inner casing wall by the tool, with the higher maximum current resulting in greater maximum pressure applied on the wall.

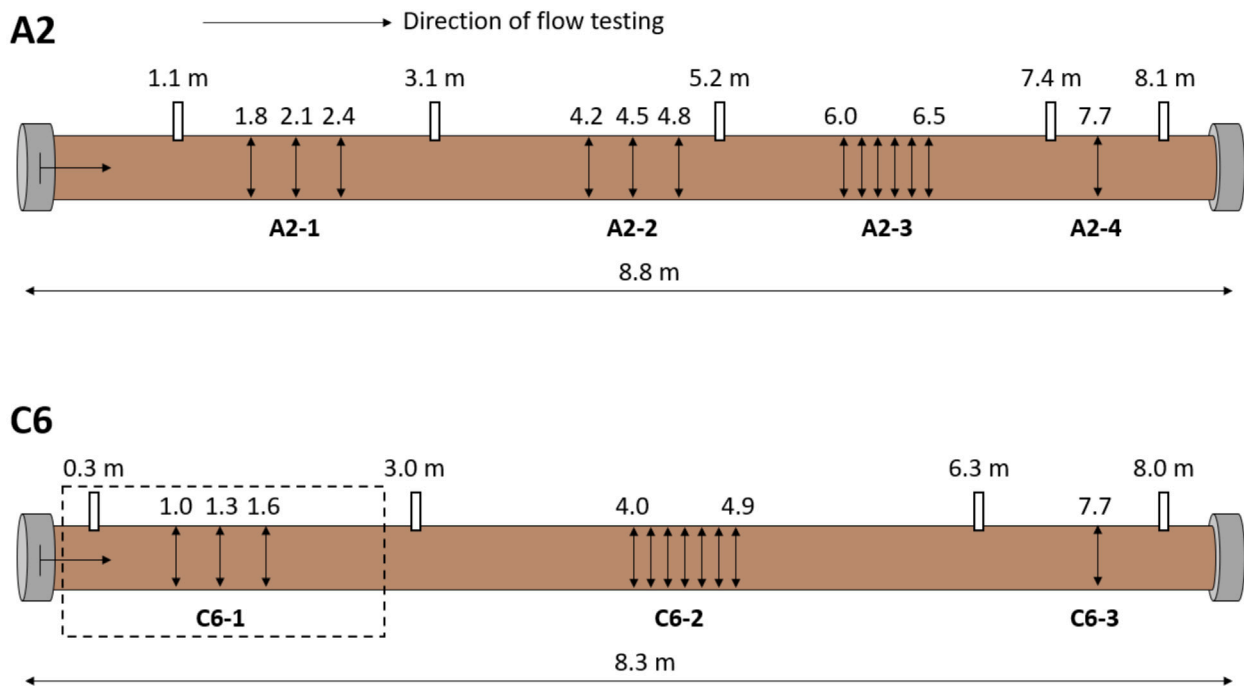
Fig. 8. Configuration of dents and pressure and flow test ports in the two test assemblies. The annular cement at set C6-1 was known to be in very poor initial condition and this segment is indicated by the dashed rectangular box. Assembly A2 and the remainder of C6 had continuous millimeter-sized channels on the top side.

Before placing the first dent in any one set, communication was confirmed between the test ports at either side of the planned set of dents. As indicated by the direction of flow testing in Fig. 8, this was achieved by connecting a pump to the test port immediately to the left of the current set of dents. The test port immediately to the right was kept open to the atmosphere. Water pressure was applied at the inlet port and the resulting flow rate was measured by a Coriolis flow meter mounted between the pump and the inlet port. The measuring range

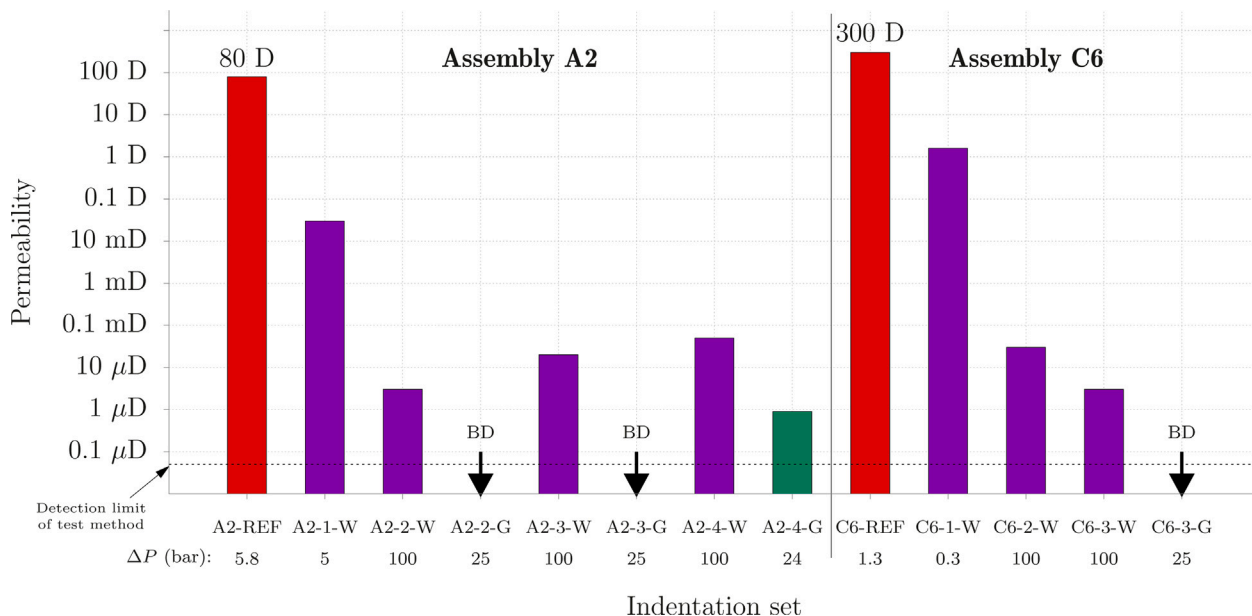
Fig. 9. Permeability measurements following the final dent per set of dents. The labels of the sets of dents are here appended with capital letter “W” or “G” to indicate whether the permeability is based on seepage testing with water (“W”) or with gas (“G”), respectively. The differential pressure used when determining the permeability is listed in parenthesis, below the label. For dents (sets) A2-2-G, A2-3-G and C6-3-G, the measured gas flow rate or pressure buildup was too low and no measurable permeability could be quantified (indicated using “BD” = “below detection”, at an estimated permeability of 0.05 μD). For reference, the average initial permeability prior to treatment, as per Table 2, is indicated by the bars labeled A2-REF and C6-REF.

0.05 μD in Fig. 9. The defined detection limit is based on a conservative assessment of the volumetric gas flux that is required to increase the annular pressure between dents by 1 bar over approximately 1 h. In practice, the actual detection limit was likely lower than this value.

Moving on to the single dent at 7.7 m in test assembly A2, we recall from Fig. 9 that the effective water permeability following this single dent was less than 0.1 mD. Compared to the dents at 1.8 m and 2.1 m studied above, the degree of casing expansion was increased and this contributed significantly to reduce the permeability. In Fig. 16 we show close-ups of the top part of the annular cement at axial positions

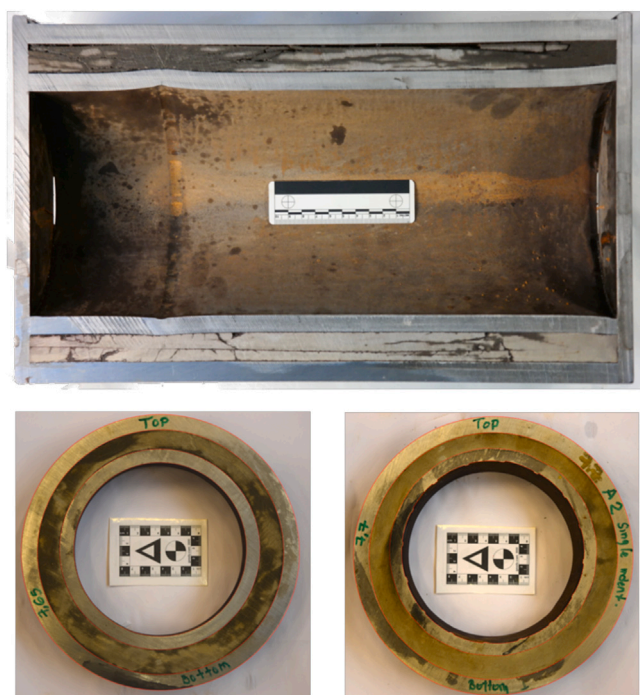
Fig. 10. Illustration of axial cut (top) and cross-sectional cuts (bottom) for assessing remediated annular cement.

Mainly the two types of cuts illustrated in Fig. 10 were performed, namely (1) axial cuts intended to expose annular cement variations at different distances from the dents along the top and bottom side of the annulus, and (2) about 5 cm thick cross-sectional cuts. In the latter cuts, one face exposed the annular cross-section directly at the dent location, while the other face gave the cross-section 5 cm away from the dent. Due to the residual stress accumulated in the casing steel, care

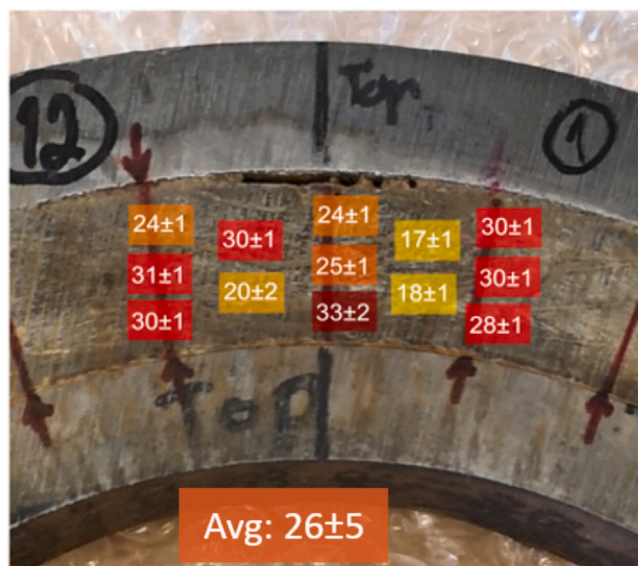
Fig. 12. Results of Vickers hardness testing in the region shown in Fig. 11.

found to be 305 HV with a standard deviation of 5 HV when tested away from the position of the dents.

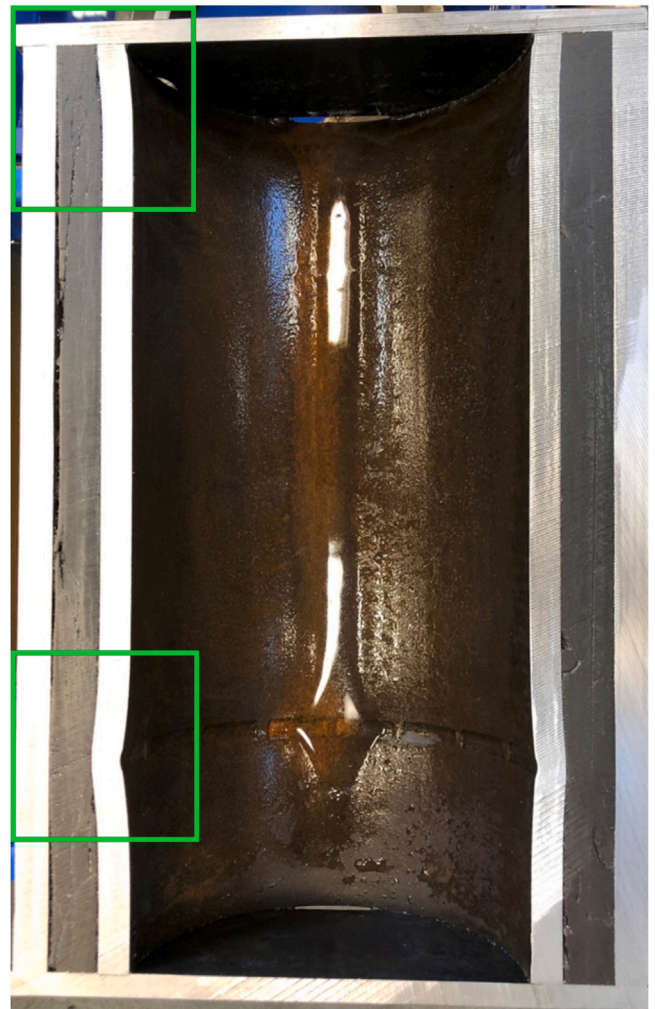
Fig. 14. Axial cross section through the dent at 1.8 m (bottom-most dent) and one half of the dent at 2.1 m (top-most dent). We observe the well-defined migration channel between the dents along the top part of the annulus (to the left in the photograph) and clear cement-casing contact areas at the levels of the two dents.

An axial view of the dents at 1.8 m and at 2.1 m is provided in Fig. 14. Here, one half of the dent at 2.1 m is shown, the other half

making up the cross-sectional view in Fig. 13. Between the two dents, we identify the channel at the top of the annular cement. At the dents, the annular cement has been compressed and is here pressing onto the inner wall of the outer casing. From the 1.8 m dent, the bottom-most dent in Fig. 14, we observe visually that the annular cement is in contact with the wall of the inner casing over an axial length of approximately 8 cm. We recall this observation being the basis for determining the effective permeability in connection with Fig. 9. Further, the annular cement has a relatively dense population of minor fractures and flaws away from the dent and we do not observe any obvious defects that could be attributed to casing expansion at the locations of the dents. Finally, Vickers hardness measurements of the dent at 1.8 m are indicated in Fig. 15, showing measurements for both cement and casing steel at the dent and short distances away. We observe a tendency for increased hardness in the cement and in the casing steel although these changes are within the standard deviations of the measurements.

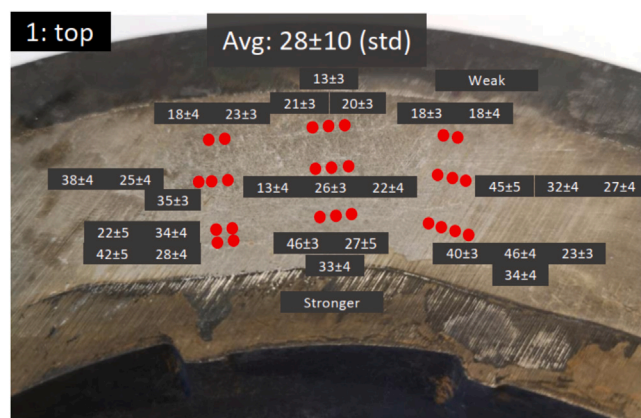
Fig. 17. Results from Vickers hardness testing at the cross-sectional cut in test assembly C6 at axial position 7.2 m. An average value of 28 HV is found, albeit with a considerable spread. The highest hardness values are consistently found close to the wall of the inner casing. We also note the distinct grooves made in the inner casing wall by the hardened steel fingers of the expansion tool.

Vickers hardness measurements have also been performed at the single dent at C6-3, with the results at the position of the dent shown in Fig. 17. We again find a considerable spread in the hardness measurements, with the highest values always being closer to the inner casing. An average value of 28 HV is found with a considerable standard deviation of 10 HV. Hardness measurements acquired at the top annular cement at a position of 7.15 m, a distance of 5 cm to the left of the dent in Fig. 17, indicate an average hardness of 23 HV, with a standard deviation of 5 HV. This is close to, or slightly less than the hardness values at the dent location of 7.2 m.

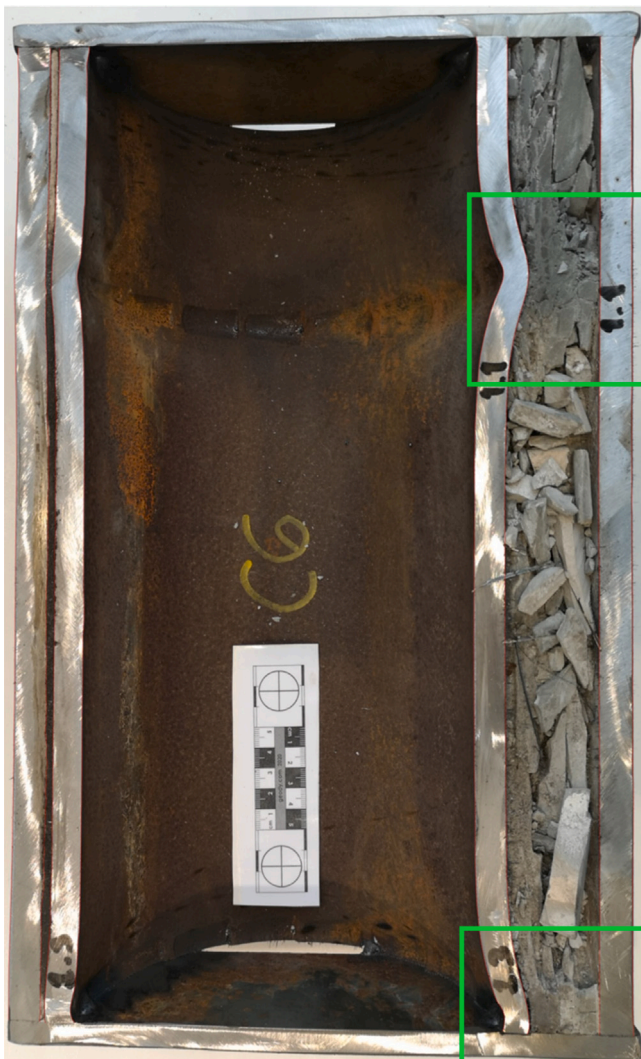
Fig. 18. Axial cross section through the dent at 1.0 m (top-most dent) and one half of the dent at 1.3 m (bottom-most dent). We observe generally fragmented and poor cement away from the dents. At 1.1 m and 1.3 m, the cement appears to have improved cohesion compared to the initial condition seen away from these positions.

Focusing on dents C6-1, set in the poorly cemented part of test assembly C6, the axial view in Fig. 18 reveals the expected very poor and fragmented initial cement condition in this part of assembly C6. However, it is interesting to note what appears to be an improvement in the cement condition at the positions of the two dents in the figure, here indicated by the rectangles, at 1.0 m and 1.3 m from the end of the assembly. Further details can be seen in Fig. 19, where the top panel shows the upper annular cross section at 1.3 m and the bottom panel is

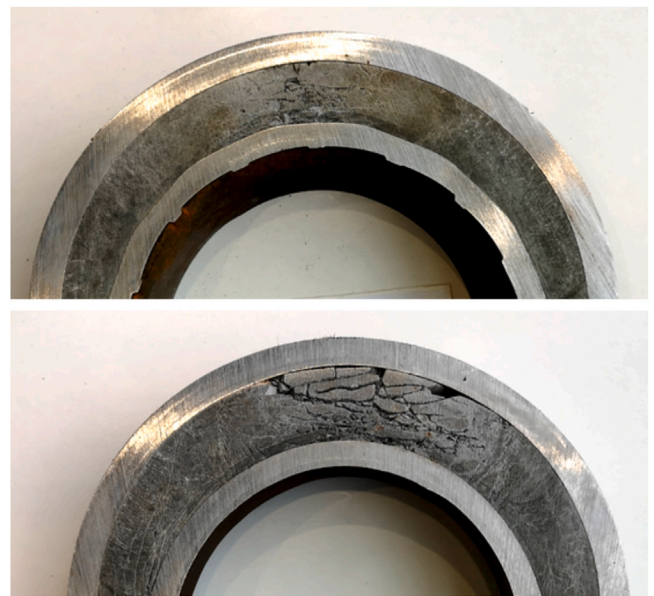
Fig. 19. Cross sectional view of the annular cement at the dent placed at 1.3 m in assembly C6 (top panel) and at 1.35 m, or 5 cm to the right of the dent (bottom panel).

from 1.35 m, or 5 cm to the right of the dent at 1.3 m. The dent in the top panel can clearly be made out by the grooves in the inner tubing wall, resulting from the local, mechanical expansion of the tubing. Although both panels show a heterogeneous and flawed cement, the cement at the dent appears to have better cohesion with less fragments compared to the bottom panel which is the cross-section some 5 cm away from the dent. We recall from Fig. 9 that the compressed cement is not sealing the annular space at this level of casing expansion and cement compression, but it is not unlikely that a greater degree of expansion could potentially have reduced the permeability further. It is worth noting here that the forming limit of the pipe was not reached, *i.e.*, in theory much larger radial expansions are possible and could also be imposed using the newest generation of LCE tools.
